REQUEST FOR DETERMINATION OF APPLICABILITY

Pare Project No. 17169.00

REVOLUTION SOCCER TRAINING CENTER Foxborough, Massachusetts

**Re: Request for Determination of Applicability
Revolution Soccer Training Center
1776 Revolution Way
Foxborough, MA
(Pare Project No. 17169.00)**

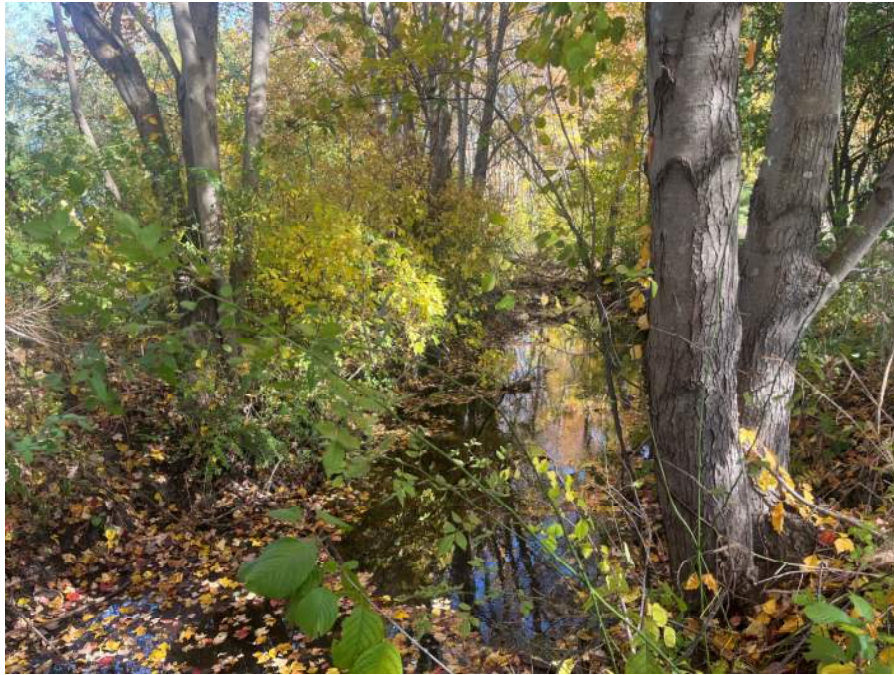
Photo 1: R-series perennial stream channel bordering north side of development site.

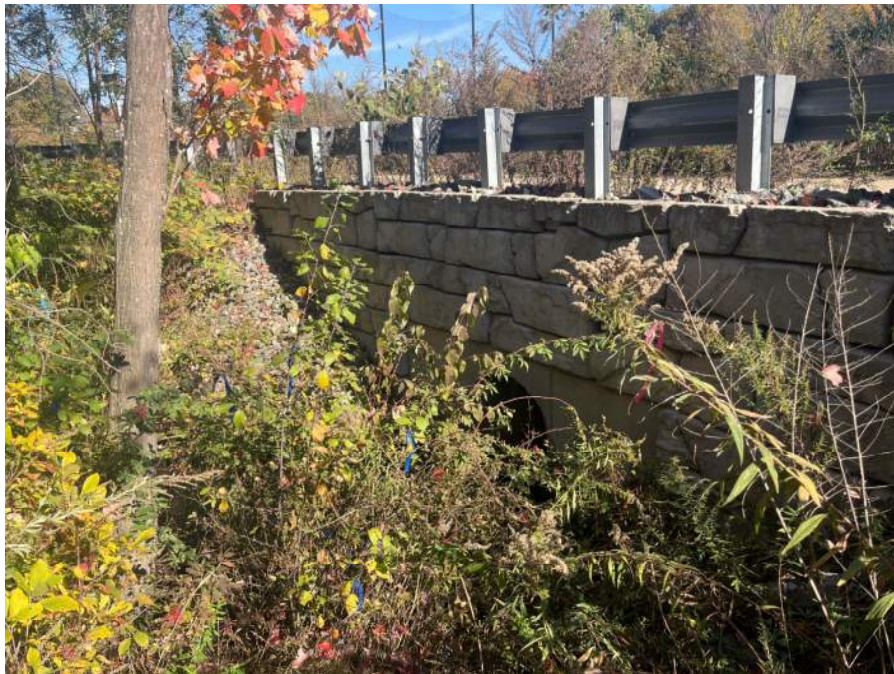
Photo 2: Recently replaced culvert passing R-series stream beneath access road.

Disturbance within the municipal 25’ No Activity Zone (NAZ) is limited to approximately 500 square feet for construction of the overflow weir. Improvements along the existing access drive over the recently replaced stream crossing will occur within previously cleared and graded. The previously permitted pedestrian walkway extending from the southeast end of the field, which included work in the 25’ NAZ and a boardwalk wetland/intermittent stream crossing, has been removed from the scope of the project.

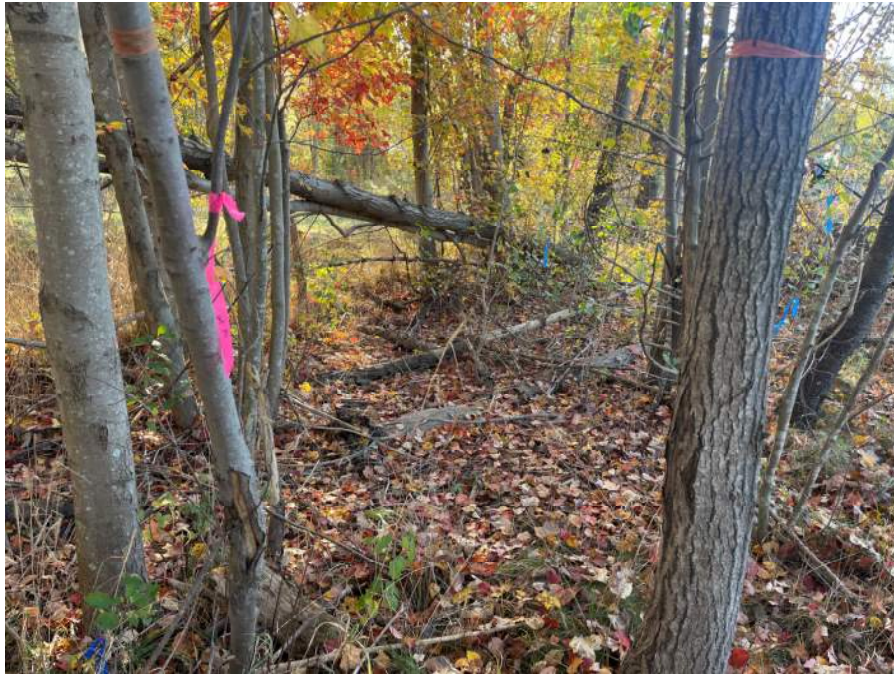
Photo 3: Non-jurisdictional isolated Wetland A to east of the proposed soccer field site.

Flag series WF A-1 to WF A-6 defines the perimeter of a shallow, rounded depression located within a previously disturbed area within the 200-foot Riverfront Area of the R-series stream. The area was delineated according to the apparent limits of flooding, indicated by water stained leaves, and predominance of wetland vegetation. The depression has an approximate surface area of 319 square feet and therefore does not meet the size criteria of an Isolated Freshwater Wetland under the Bylaw. The area did not hold any standing water during the delineation, however water-stained leaves indicate that the area experiences a small amount of flooding. The area appears to exhibit a temporarily flooded hydrology, and primarily fed by surface runoff from the surrounding disturbed areas. The area is sparsely forested by a mixture of young trees with a dense understory of shrubs and climbing vines, including some invasive species. Vegetation identified within the area included the following species:

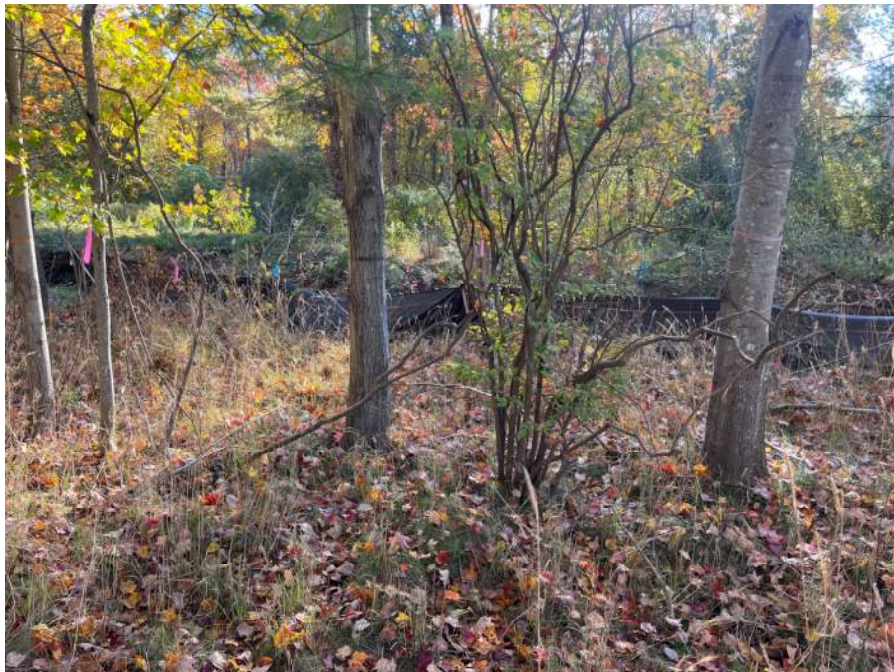
Photo 4: Non-jurisdictional isolated Wetland B to the northeast of the proposed soccer field site.

Flag series WF B-1 to WF B-8 defines the perimeter of a shallow, rounded depression located within a previously disturbed area within the 200-foot Riverfront Area of the R-series stream, just adjacent to a gravel walkway. The area was delineated according to the apparent limits of flooding, indicated by water staining on the ground surface, and predominance of wetland vegetation. The depression has an approximate surface area of 483 square feet and therefore does not meet the size criteria of an Isolated Freshwater Wetland under the Bylaw. The area did not hold any standing water during the delineation, however water-stained leaves indicate that the area experiences a small amount of flooding. The area appears to exhibit a temporarily flooded hydrology, and primarily fed by surface runoff from the surrounding disturbed areas and walkway. The area is sparsely forested by a mixture of young trees with a dense understory of shrubs and climbing vines, including some invasive species. Vegetation identified within the area included the following species:

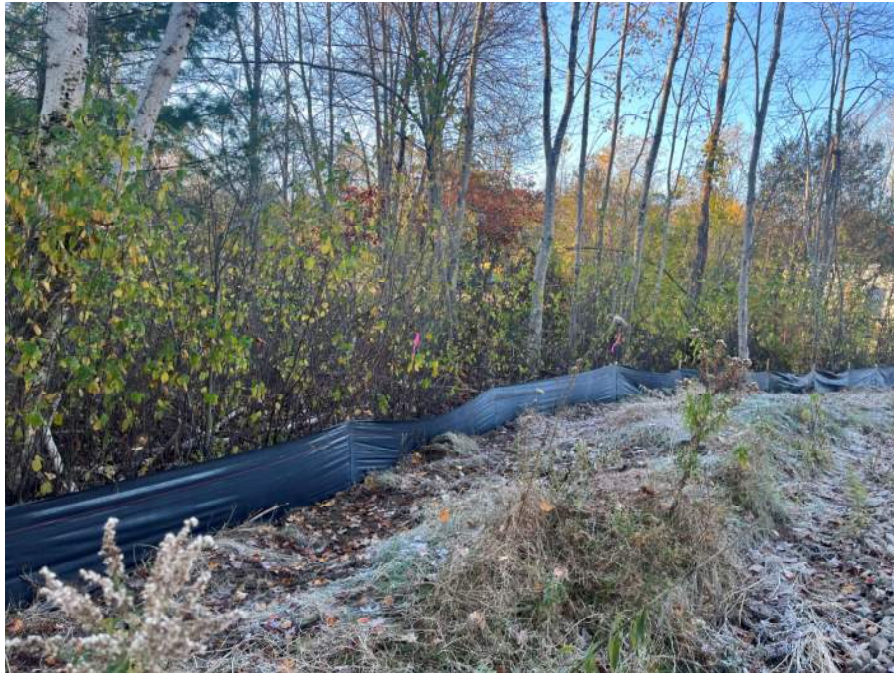
Photo 5: Wetland C edge along the limit of clearing completed under former OOC.

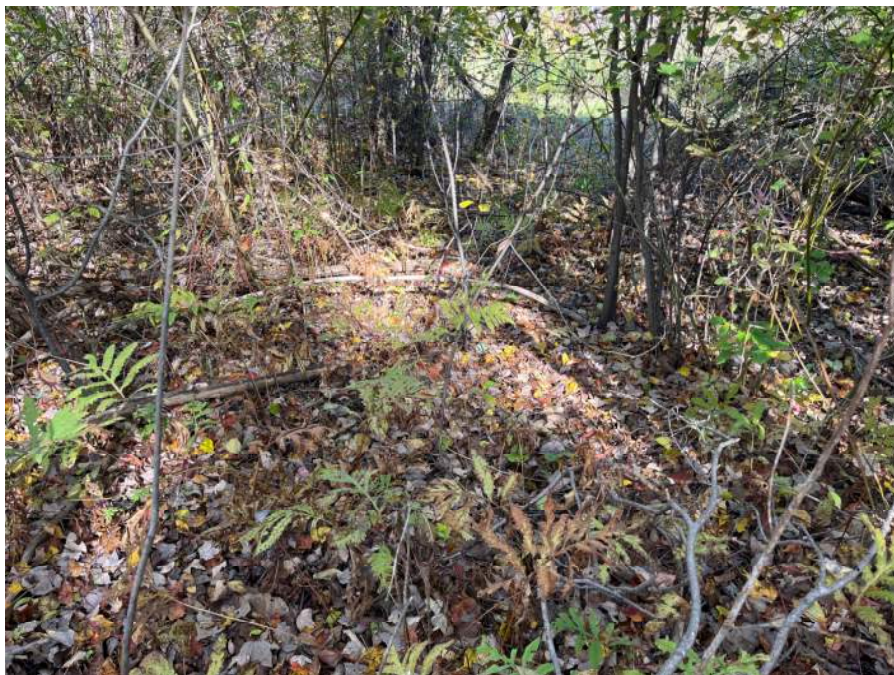
Photo 6: Typical view of Wetland C interior.

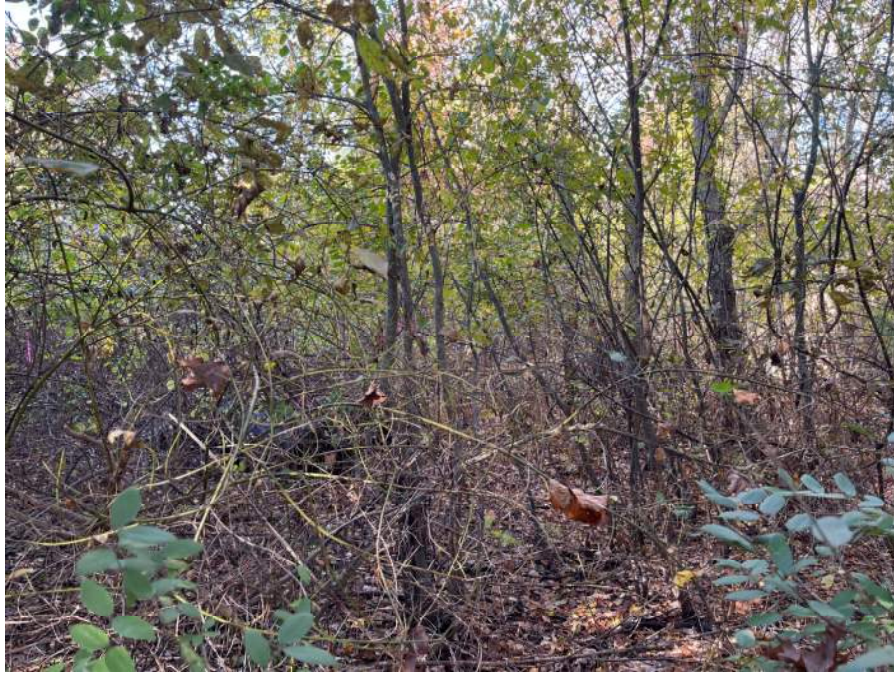
Photo 7: Typical view of Isolated Wetland D.

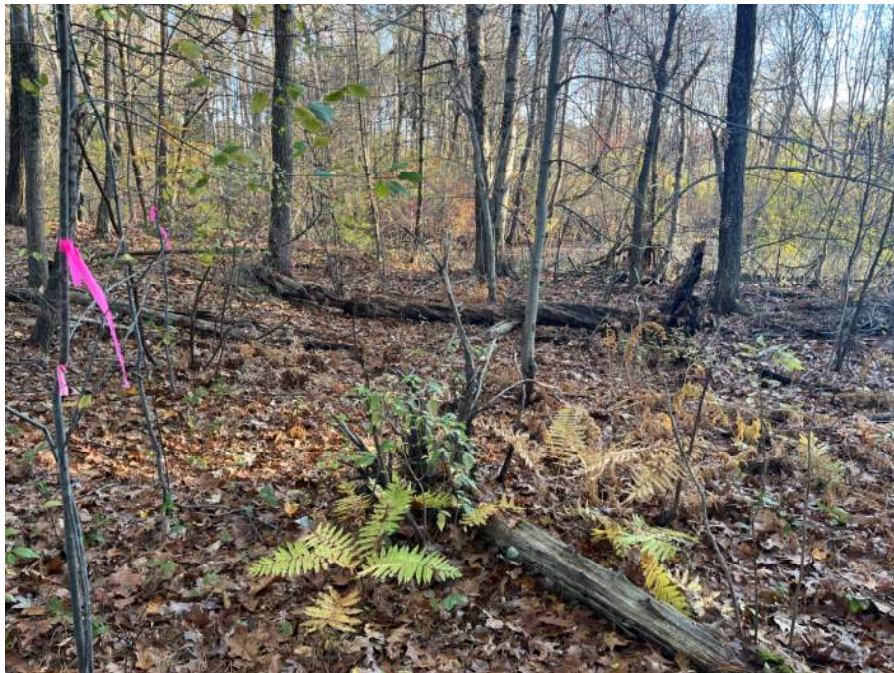
Photo 8: Wetland E BVW edge, facing downslope toward semipermanently flooded PVP in interior.

According to MassGIS data layer pvp_pt.shp, a potential vernal pool (PVP #7886) is located at a low spot in the wetland interior. Investigations completed during the permitting for the Revolution Training Center project found that the flooded area in the wetland interior supports vernal pool wildlife and appears to qualify for protection as a certifiable vernal pool. As such, the area has an associated **100-foot vernal pool buffer zone** under the Bylaw.

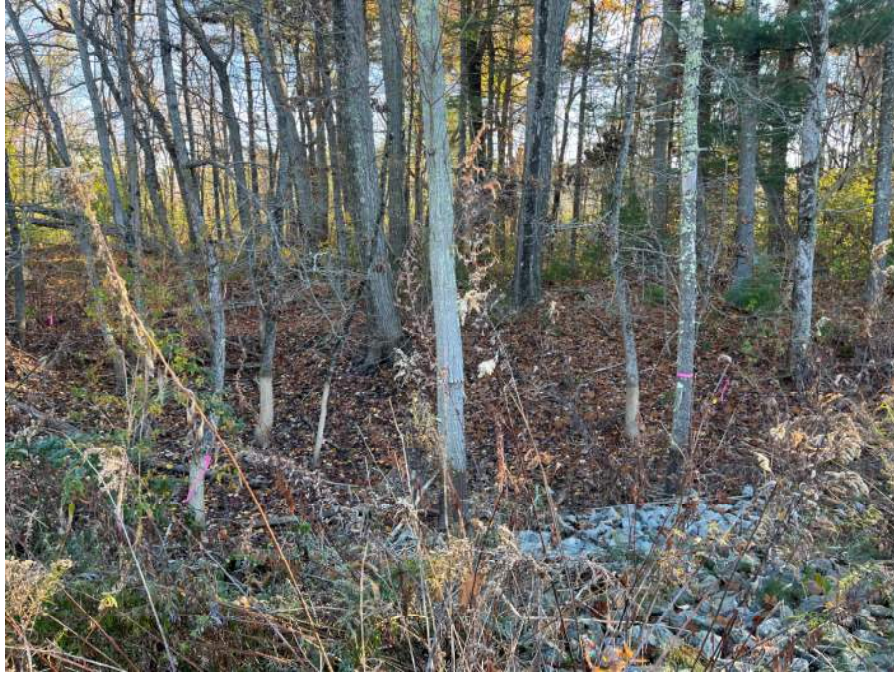
Photo 9: Wetland F, Isolated Freshwater Wetland, facing downslope from irrigation pond.

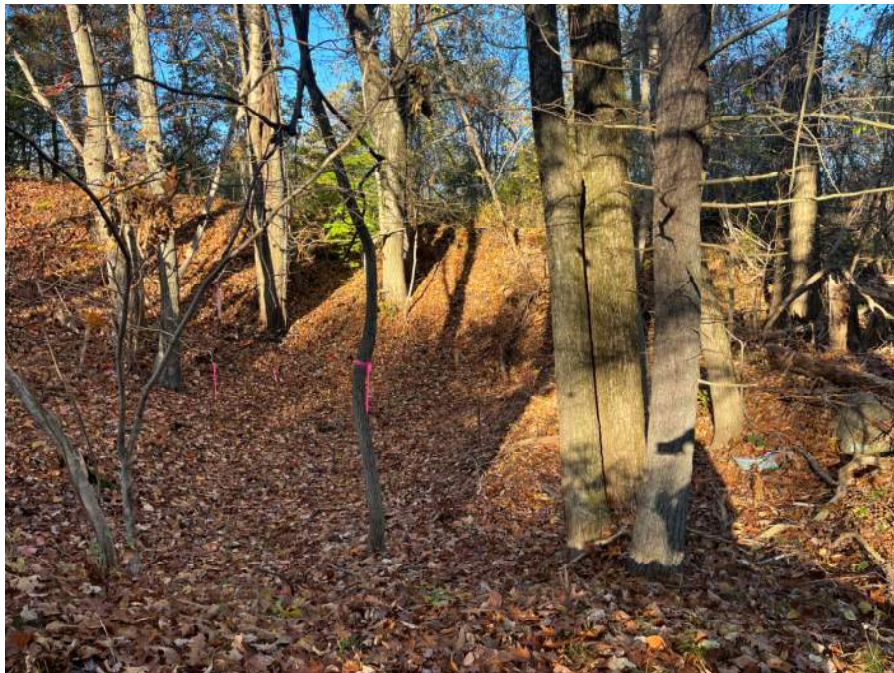
Photo 10: Non-jurisdictional isolated Wetland G at the south side of development area.

Flag series WF G-1 to WF G-7 defines the perimeter of a small depression located within a highly disturbed wooded area to the south of the development site. Based on the 1978 aerial photograph of the area, it appears to have been disturbed during the gravel mining activities onsite. Irregular topography and spoil piles within the surrounding area indicates the area was previously disturbed. The area was delineated according to the apparent limits of flooding, indicated by water staining on the ground, and hydric soils. The depression has an approximate surface area of 419 square feet and therefore does not meet the size criteria of an Isolated Freshwater Wetland under the Bylaw.

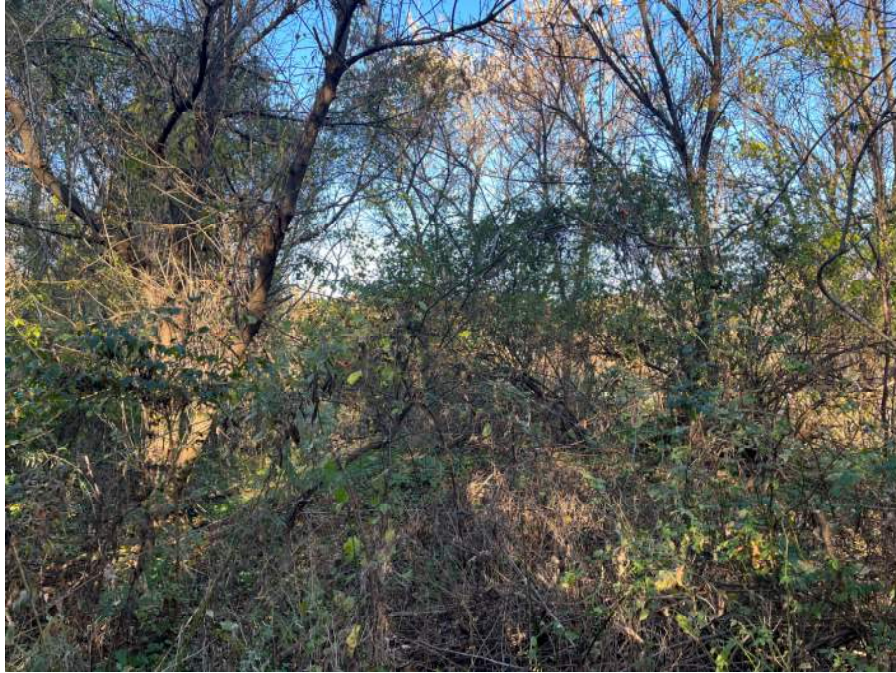
Photo 11: Isolated Freshwater Wetland H, facing downslope from north edge.

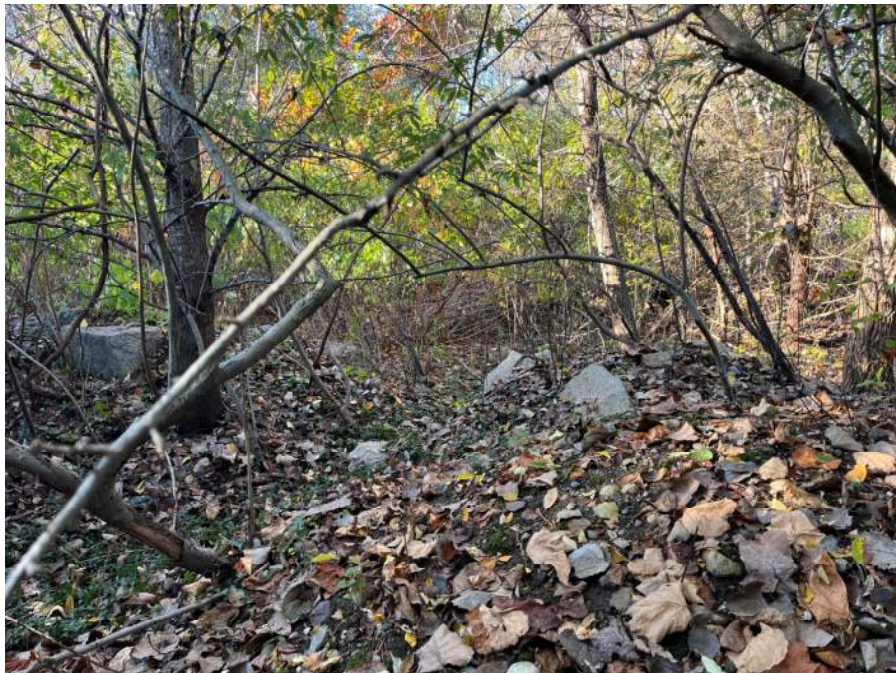
Photo 12: Typical view of upland wooded area within the proposed limits of clearing. This area primarily consists of early successional forest with dense invasive understory.

Most of the work is to occur within previously disturbed areas on the site, and additional clearing is primarily confined to significantly disturbed early successional areas that were part of a former gravel mining operations. Spoil piles, debris, and dense invasive species are present throughout these areas.

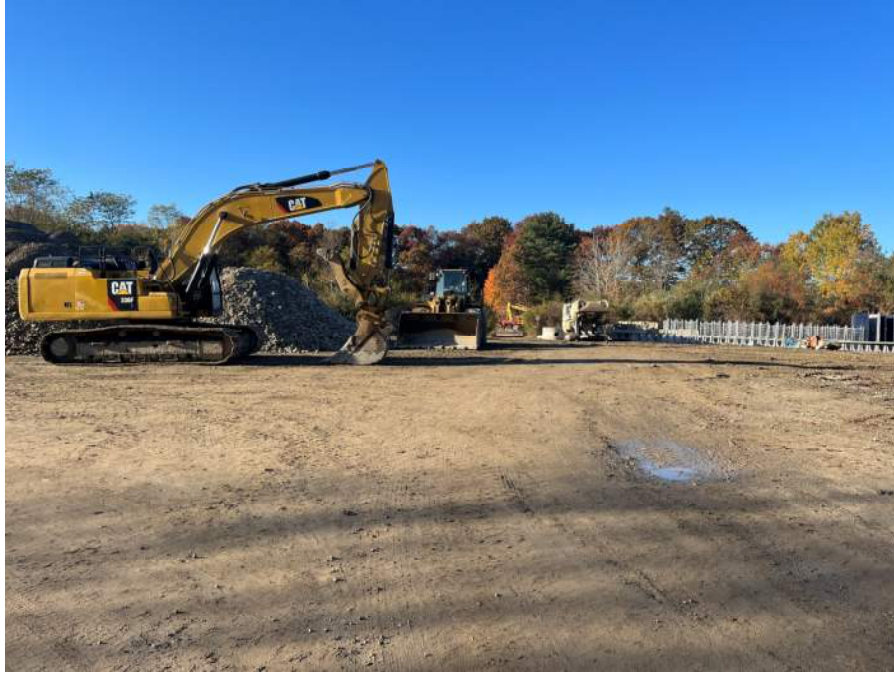
Photo 13: Central portion of development site, which has been cleared and graded under the former OOC.

The site of the proposed west soccer field and associated parking area consists primarily of cleared, leveled land which was prepared for development under the OOC, and is currently being used for equipment staging. Sediment controls are present along the perimeter of the cleared area and are currently in good condition. The southernmost extent of the work area is located within the tree line, however this area is outside of the buffer zone and Riverfront Area. The remaining vegetated areas in the limits of work are primarily colonized by early successional forested and sapling/shrub dominated areas with high densities of invasive understory growth. The proposed limits of disturbance overlaid against the existing limits of clearing are shown on the attached Plan Sheet entitled "Limit of Work on Aerial", attached in Section 4.

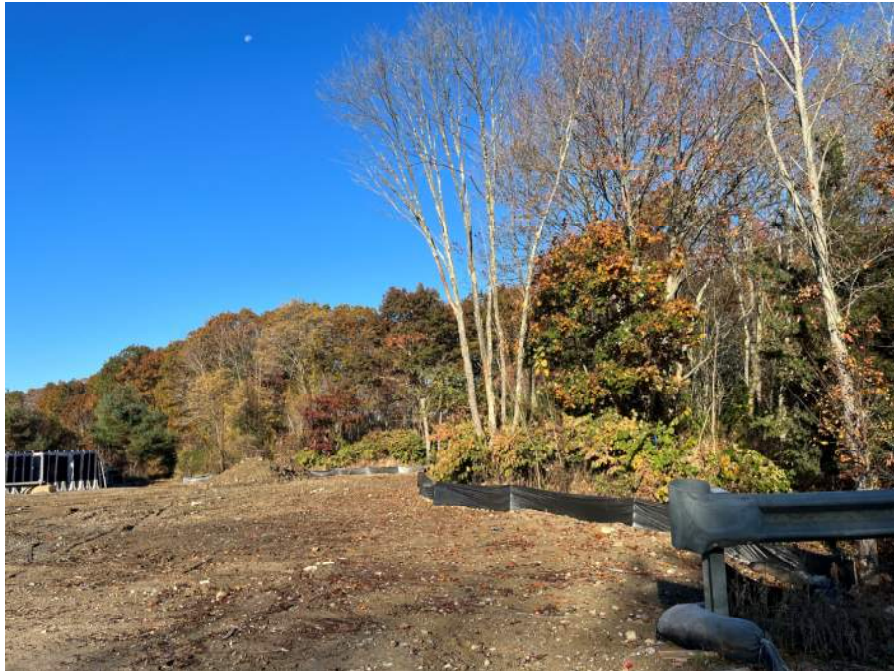
Photo 14: Eastern portion of prepared site. Silt fence along treeline has recently been replaced.
